Kennebec Barrier Survey 2010

Grantee: Merrymeeting Bay Trust

Prepared by: Charles Baeder, Sheepscot River Watershed Council,
Dale Finseth, Kennebec Valley Soil & Water Conservation District, and
Carrie Kinne, Kennebec Estuary Land Trust

Revised May 7, 2011

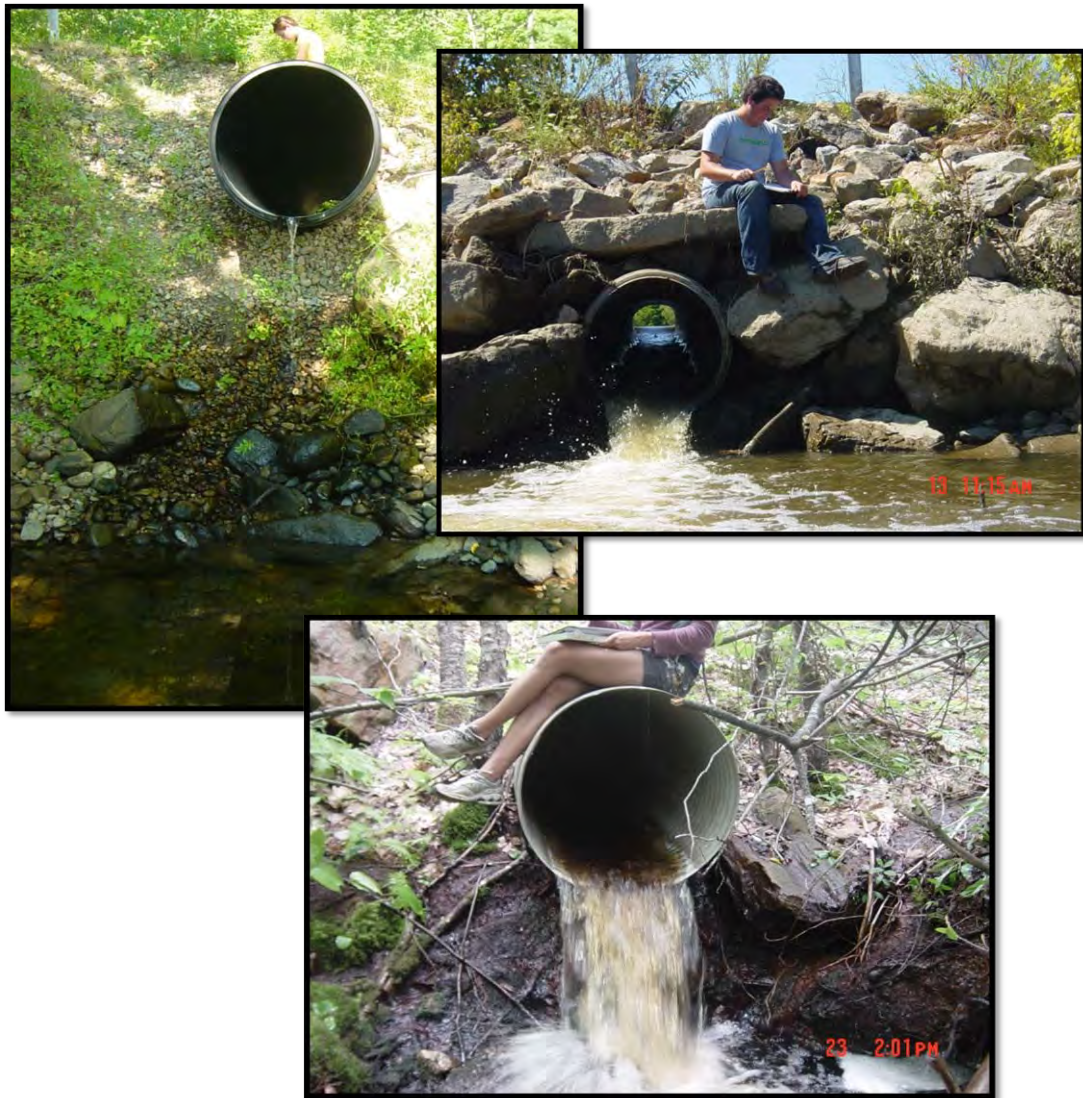
Perched culverts are defined as culverts whose inlet or outlet is elevated above stream grade, thus preventing or impairing fish passage. Perched culverts are typically referred to as “hanging” culverts by public works officials. The following pictures illustrate perched culverts.

Perch height, the distance from the bottom of the pipe to the water level of the stream, was also measured. For outlet perched culverts where perch height was measured ($n=117$), the median perch height was 0.18 meters and the mean perch height was 0.35 meters. All outlet perched culverts are considered “severe” barriers, but the severity of the perch and the evaluation of perch height under different flow conditions is worthy of additional consideration on at least a site basis when considering restoration projects.

For the reasons noted above – perching, blockage, velocity barriers, and no substrate – undersized culverts have been targeted by fisheries biologists for replacement with fish friendly culverts. Culvert sizing recommendations made by biologists have supported a 1.2x bankfull width standard for the last decade, meaning that a culvert’s diameter should be 1.2x (120%) larger than the bankfull width of the stream it will pass. This sizing standard, when properly implemented, improves fish and aquatic organism passage and habitat.

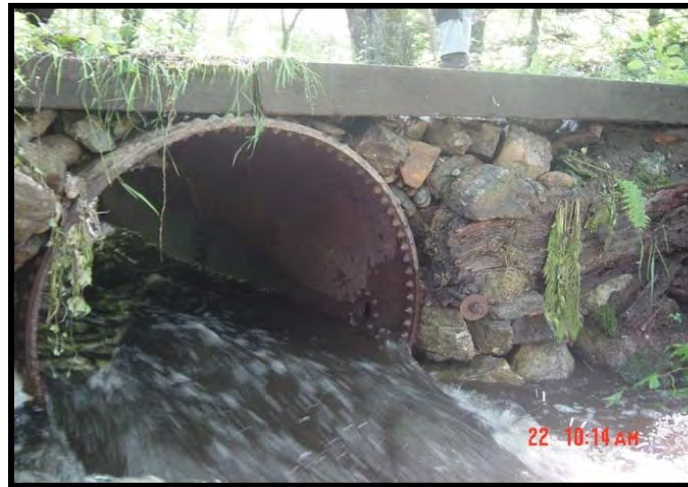
There are several reasons why culverts are perched. Sometimes it is done to block invasive fish, e.g., Northern pike, from entering an upstream watershed (rare). Sometimes they are installed with an inlet or outlet elevated above stream grade because of ledge (common). More often culverts which are now perched were originally installed at stream grade but were undersized for the volume of water they were required to pass. When culverts are undersized water accelerates and causes a “hose” effect which erodes downstream substrate in the stream channel resulting in an elevated “perch”. This hose effect is illustrated in the photo.

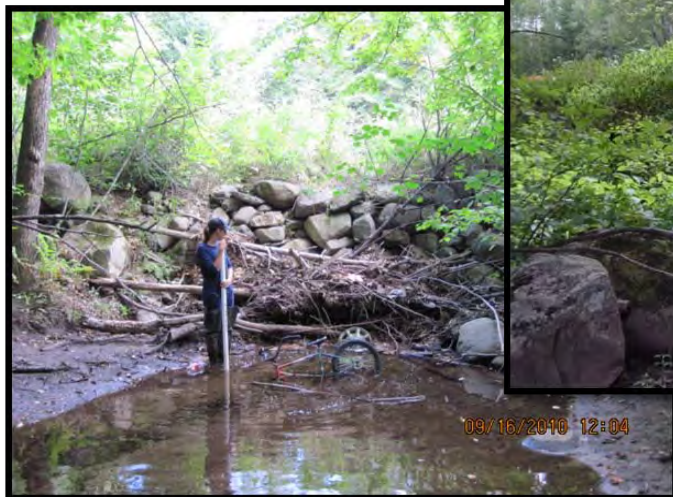
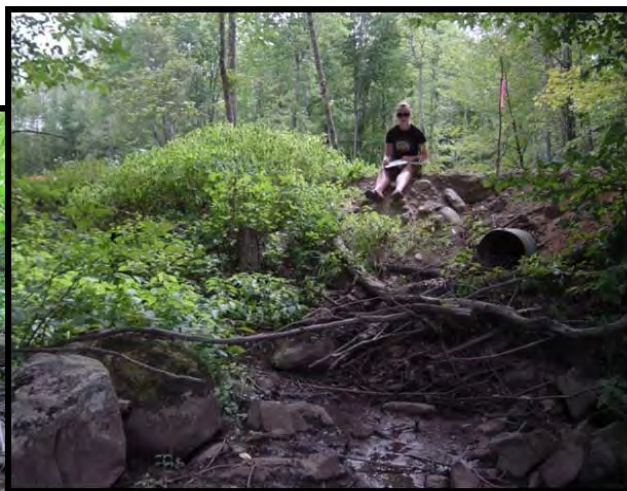
Blockages are significant fish passage barriers and were present in 9.82% of all culverts (n=33). In addition to 21 “severe” barriers – the “severe” definition is =>50% blocked – another 12 culverts were 25% blocked. Nine of the severely blocked culverts were also outlet perched culverts. Both conditions are caused or made worse by undersized culverts. Representative photos illustrate the problem.

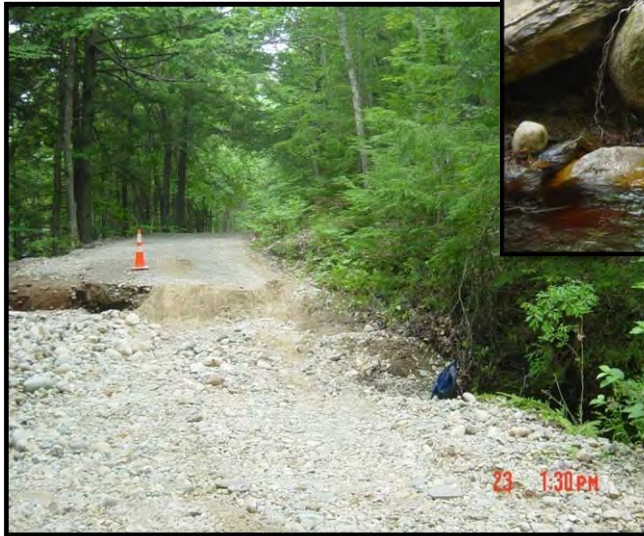
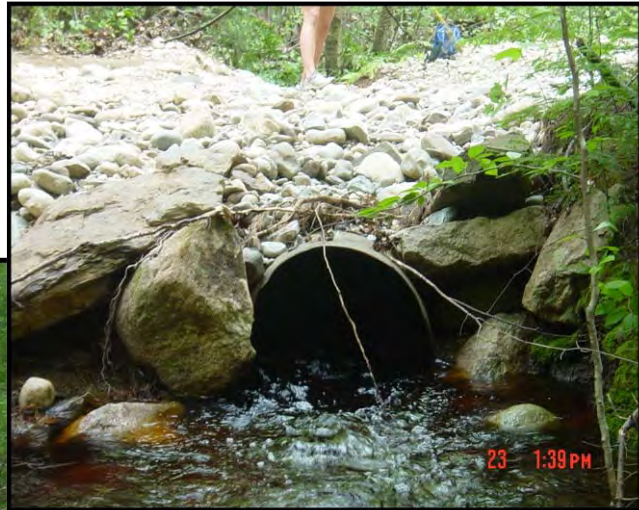
One of our survey crews observed this firsthand in the lower Kennebec watershed on Meadowbrook Road in Phippsburg following a storm in July 2010 that washed out the road. These photographs show the road after initial repairs were started and what appears to be the re-installation of an undersized culvert. Road failures were observed on a larger scale in Downeast Maine following a December 2010 storm that blew out several roads in that region. Culverts in that same area that had been replaced in the last few years by

Project SHARE with culverts sized at 1.2x bankfull width in order to restore fish passage weathered the storm without incident. In addition to impairing fish passage, undersized culverts are clearly a road infrastructure, public safety, and FEMA cost issue.

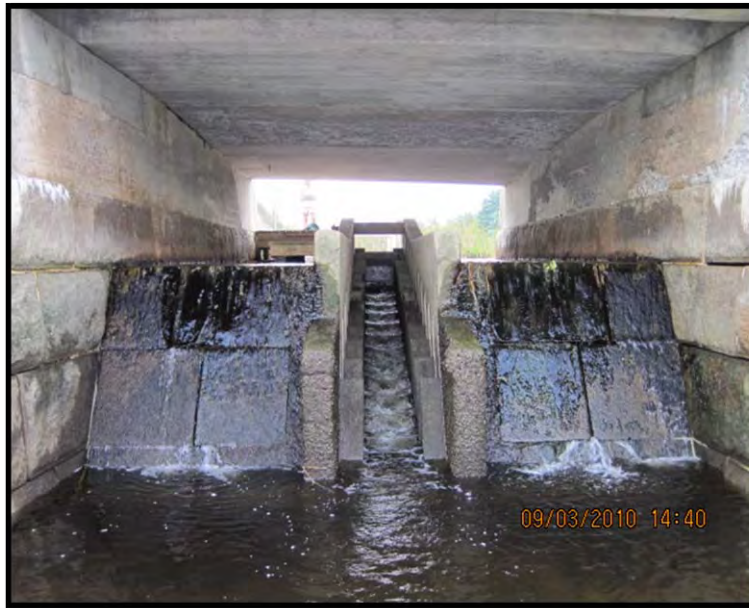
Winnegance Creek Dam with fish ladder, Phippsburg

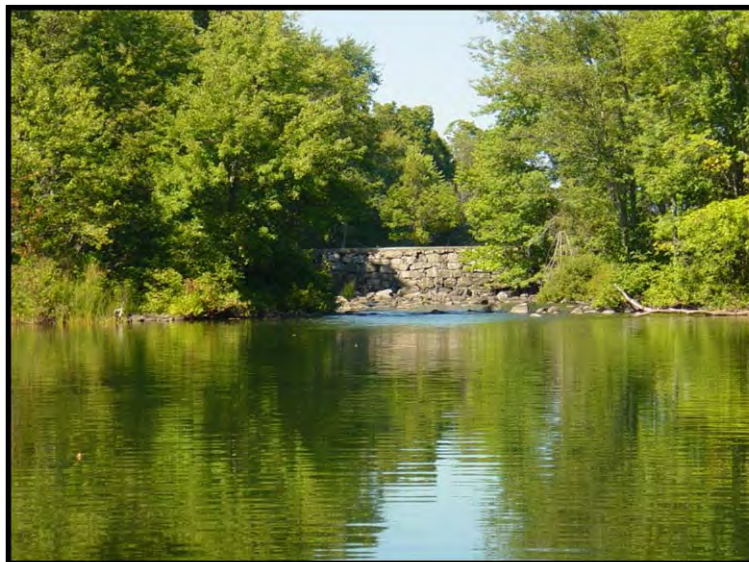
Cobbossee Stream, West Gardiner

Dams were also surveyed as part of this project. Most dams are “severe” fish passage barriers as they lack fish ladders. Nineteen dams were surveyed and only three have fish ladders, one of which leaks and is in need of repair. Representative photos of dams with and without fish ladders are shown below.
